NON-DESTRUCTIVE AND MECHANICAL ASSESSMENT OF ENVIRONMENTAL DECAY IN MASONRY: A LABORATORY EXPERIENCE

Dissertation Submitted to partial fulfilment of the requirements for
MASTER IN CIVIL ENGINEERING - BUILDING CONSTRUCTION

DEPARTMENT OF CIVIL ENGINEERING

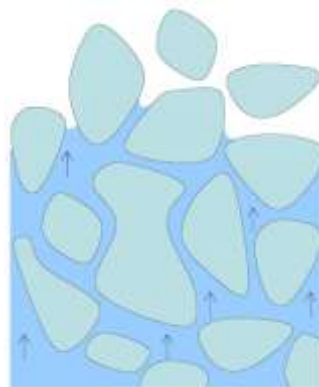
Fig 2.2 - Illustration of water flow through capillaries (Rirsch and Zhang, 2010)

Water is an essential part of the process of brick and mortar manufacturing. In brick production, the wet clay is moulded and then fired to produce a structure with a network of pores. The pores are the residual volume that the evaporating water has left behind. Likewise in cement mortar, a large volume of unreacted water evaporates in the mortar curing process and leaves a network of pores behind. Similar pore networks are found in many types of natural stone. Pores and voids are inherently present in these building materials. It is these networks that subsequently become the pathways through which groundwater can rise as shown in fig 2.2 (Rirsch and Zhang, 2010).

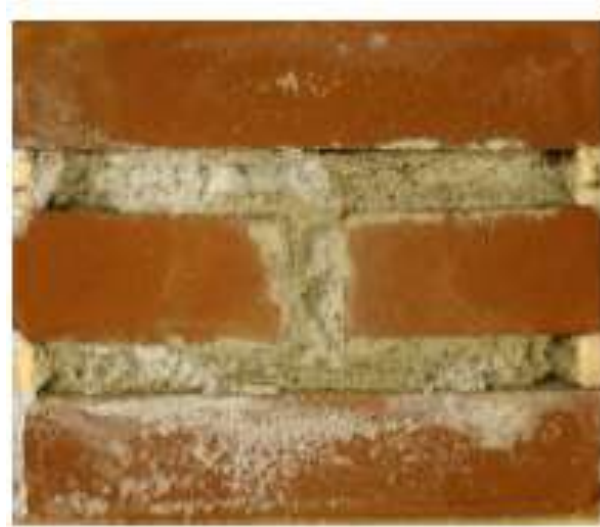
Fig 2.4 - Salt crystallization in a brick wall (Tedeschi et al., 2011)

Efflorescence are salts crystals (fig2.4), usually white, that lay on the surface of bricks, mortars, roof tiles, ceramic tiles, concrete floors and masonry rock walls. The efflorescence formation involves processes of dissolution-crystallisation of salts and it essentially depends on three main aspects: presence of soluble salts, water and hydrostatic pressure.

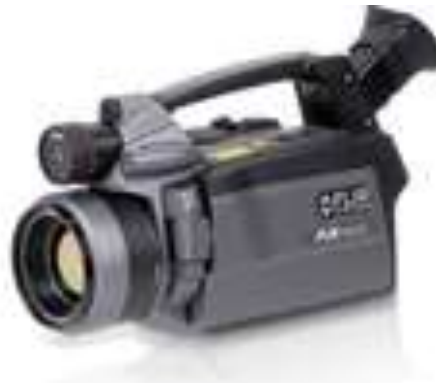
Fig 3.13 - Termocamera - FLIR P620("FLIR")

As an example of application of thermography test is presented. Two images of a thermographic test carried out in an ancient building, in Bologna, fig 3.12. It is possible to detect some hidden features in the wall analysed by the termogram. It's easy to observe an old arc above the window that was later covered. The termocamera used was a FLIR P620, fig 3.13.

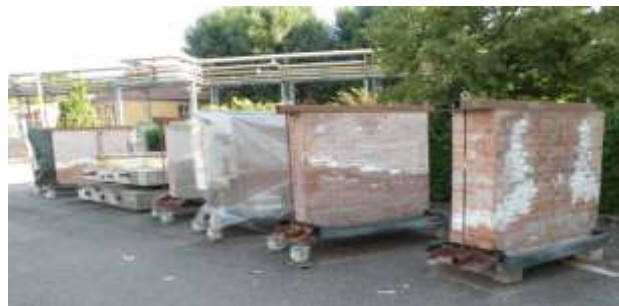
Fig 4.3 - Walls exposed to the natural weathering and immersed in different types of solutions on the base.

The procedure with the walls was similar, six different large-scale walls were positioned outside during four summer seasons, fig 4.3. These walls were partially immersed in different types of solutions, tap water, NaCl, Na₂SO₄ and just with the action of the rain water.

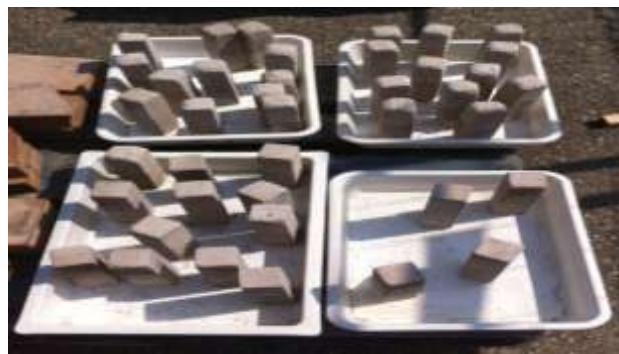
Fig 4.4 - Four sets of mortar prisms (Dry, NaCl, Na₂SO₄ and Water)

Non-destructive testing of material was carried, consisting in four sets of mortars prisms (Fig 4.4), three sets of bricks, fig 4.5 and four sets of different stones fig 4.6, these specimens were partially immersed in different solutions to induce capillary rise. Effect of salt damaging were analysed, with solutions of sodium chloride and sodium sulphate. Moreover, it was performed the tests with dry samples and with samples in contact only with tap water. These type of salts were chosen because they are one of the most common damaging salts for existing masonry structures and the low-concentration of the solution is similar to cases of low-salinity groundwater. Every season cycle the samples were turned, changing the side in contact with the solution, thus can be achieved a constant impregnation of the material.

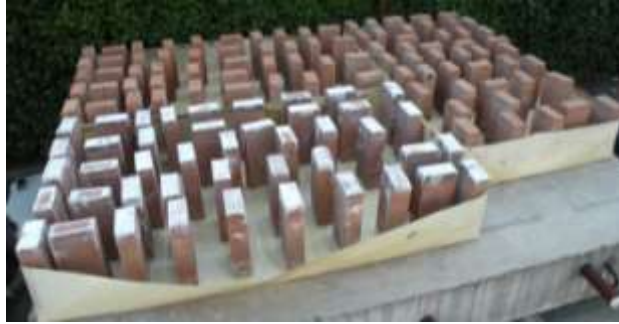
Fig 4.5 - Tree sets of bricks (NaCl , Na_2SO_4 and Water)

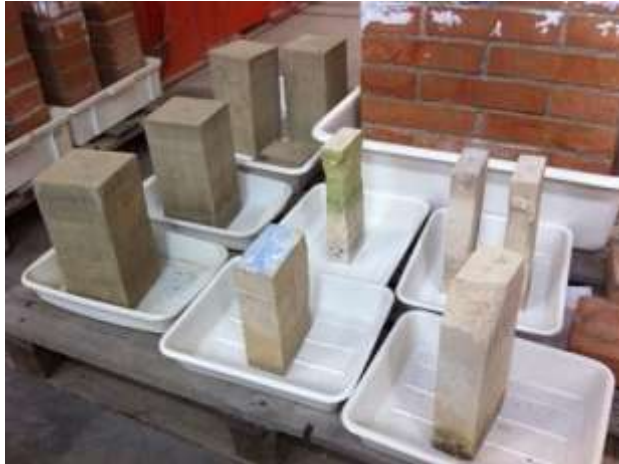
Fig 4.6 - Stone Samples

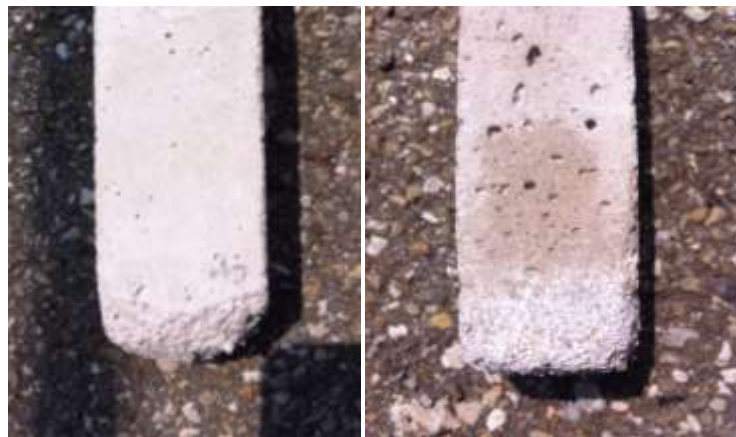
Fig 5.1 - Mortar Prism - NaCl (left) ; Mortar Prism - Na_2SO_4 (right)

In order to determinate the state of damage of the material, the first analysis done should be a visual assessment of the state of the specimens that will be analyzed. In this case, an ultrasonic test was carried out in samples of mortars, bricks and stones. Through a visual inspection, it is observed that the samples of mortar are already quite damaged, having a configuration with rounded edges and lost some of their mass. The material seems quite porous, rough, and little homogeneous, Fig 5.1. Samples in contact with Na_2SO_4 show salt efflorescence in the base in contact with the solution in the last season.

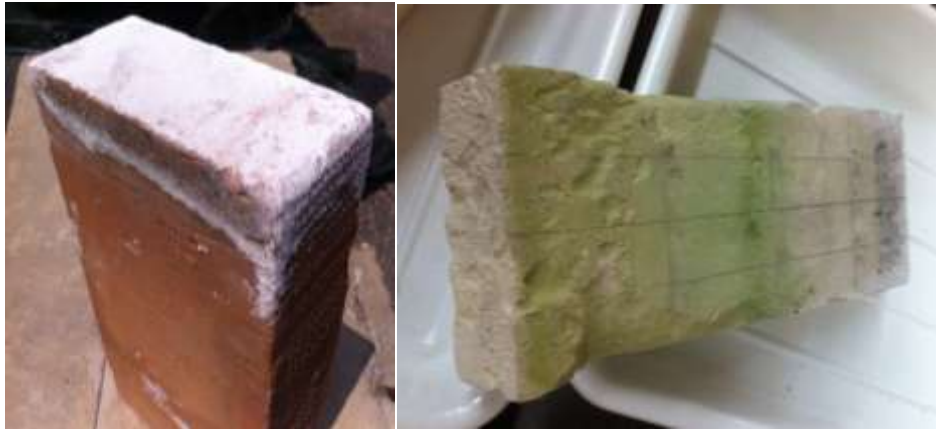
Fig 5.2 - Na_2SO_4 brick sample (left) ; Limestone from Lecce (right)

Limestone samples from Lecce, present quite deterioration as well as a large amount of mass loss, fig 5.2. Trough the visual inspections, the others types of stones seem to have a more regular surface.

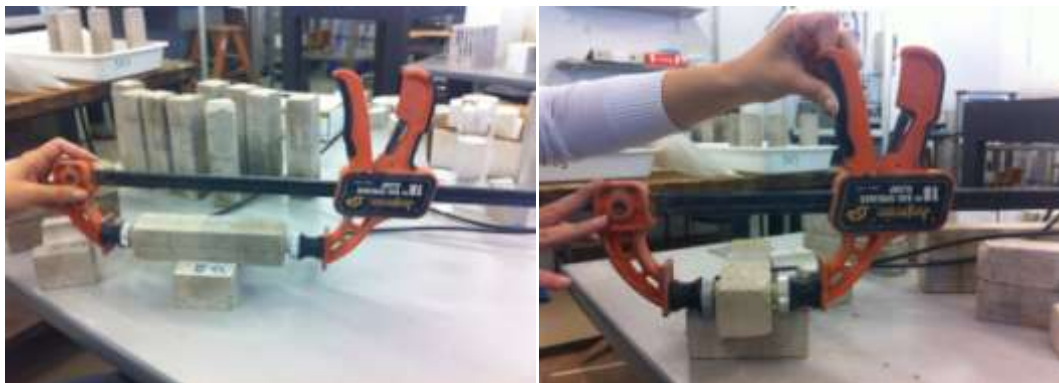
Fig 5.6 - Mortar prisms - US longitudinal path (left) ; US transversal path (right)

Ultrasound test was performed by direct transmission in mortar specimens properly marked with the grid in order to perform the test with the greatest accuracy possible. From the direct reading of the device it was possible to obtain the values of the time of flight and attenuation, subsequently the value of the wave velocity was calculated as: $V_p = \text{tof} / \text{thickness of specimen}$. The analysis was performed for the four types of specimens: dry, NaCl, Na₂SO₄ and with water. Two paths were considered, longitudinal (A-B) and transversal past in three tests per sample: 1-1', 2-2', 3-3'.

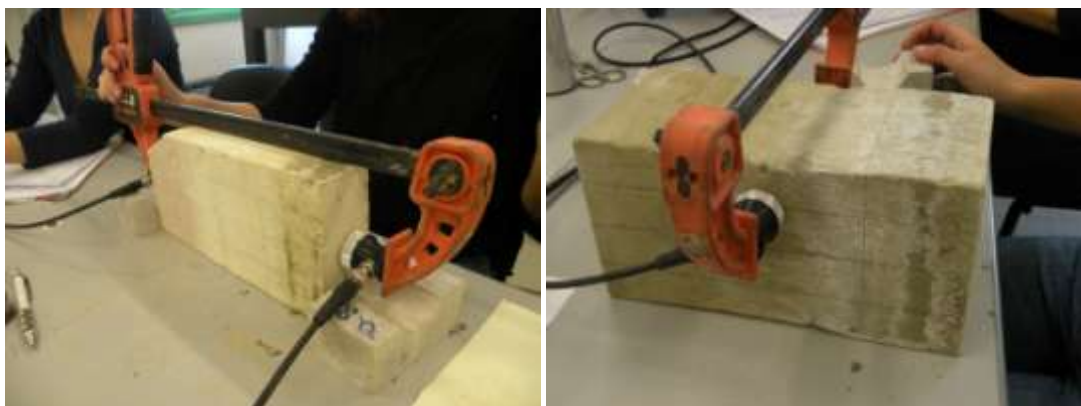
Fig 5.33 - Stones - US Longitudinal Path (left) ; US Transversal Path (right)

As described in this chapter, the ultrasonic test was also performed on samples of different types of stones. In this case, the direct test was made in accordance with the grid presented in fig.5.3. Two different transversal paths were considered (A, B and C), (4-4', 5-5' and 6-6'). The analysis was performed on four different samples types of stone, sandstone from the "Varignana", sandstone from "Stuttgart", a Limestone from "Leccese", and a Limestone from Palestine.

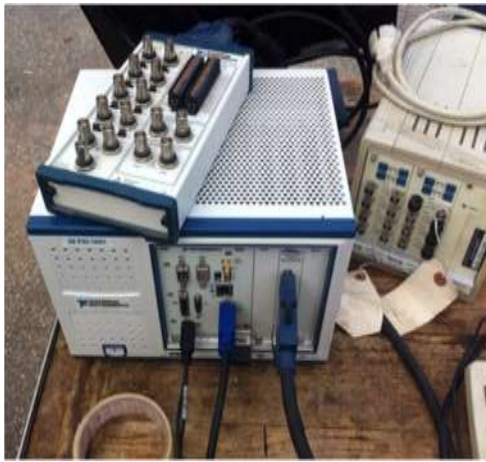
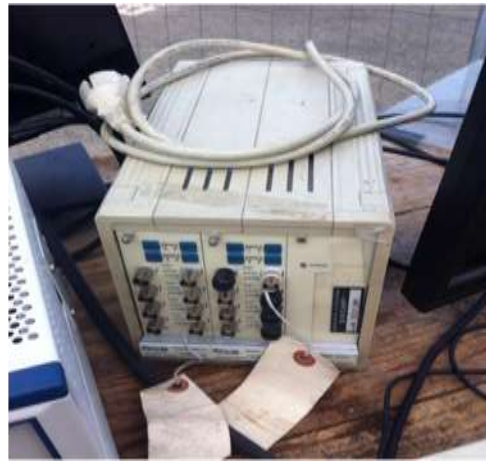
Fig 6.2 - Computer (left) ; Amplifier (right)

- Computer, fig 6.2 (left)
- Amplifier, fig 6.2 (right)
- Hammer PCB 086-berillium tip, fig 6.3 (left)
- Microaccelerometer, fig 6.3 (right)
- Display

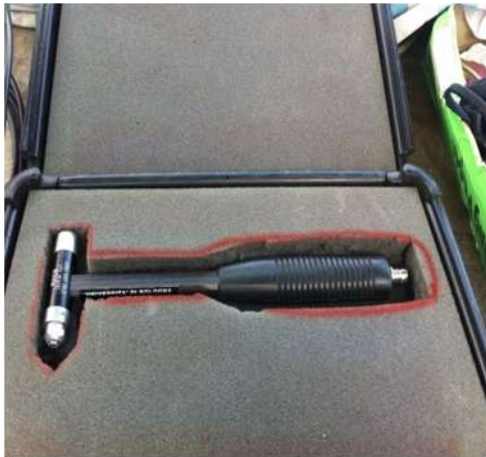
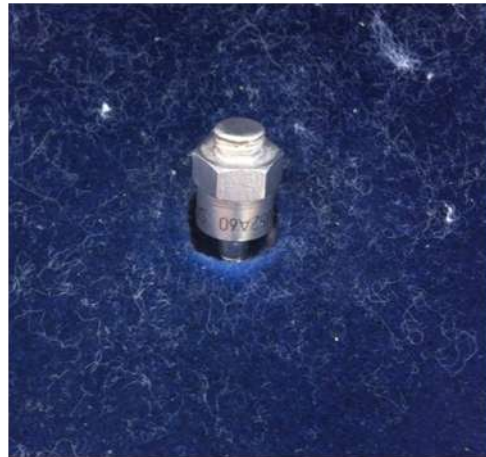
Fig 6.3 - Hammer PCB 086 (left) ; Microaccelerometer (right)

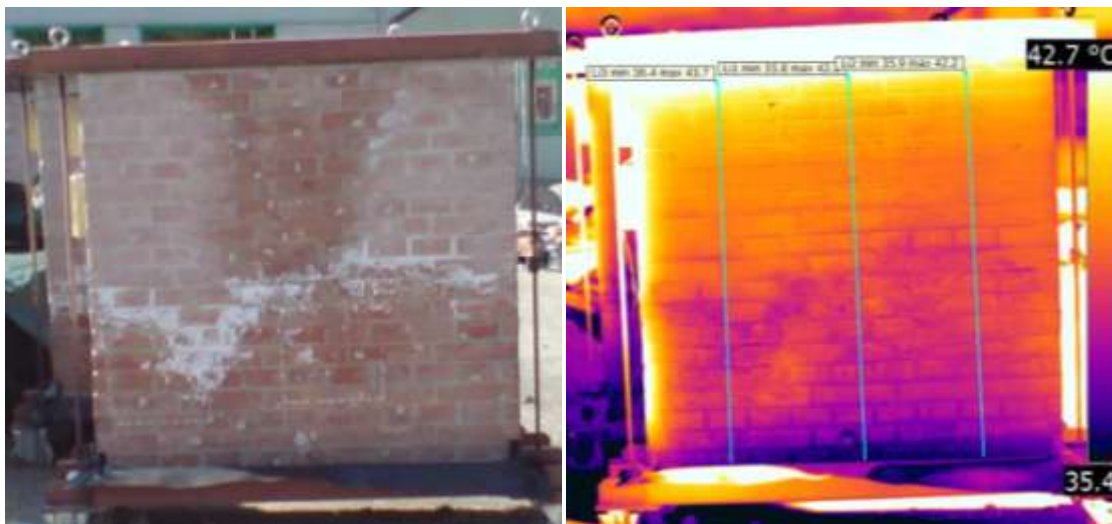
Fig 6.24 - Wall PNDE front (left) ; thermogram (IR_21932)

Thermographic test in wall PNDE was performed on 5th of June 2014 and with a distance from the wall of 4.70m. The presented thermogram (IR_21932) was post-processed in order to better identify the characteristics of the wall. From the picture taken to PNDE wall front (Fig 6.24, left), immersed in a solution of Na_2SO_4 (0.05% by weight), different colours can be observed in surface material. This wall also presents a white line corresponding to the formation of salt efflorescence; below this line, the darker material is due presence of moisture by the action of rising damp. The dark coloration at the top

is due to the rain precipitation to which the wall has been subjected and that somehow caused a colour change of material.

From the thermogram (IR_21932) obtained, the contrast of colours, thus the temperatures, between the top and bottom of the wall is very evident. The darkest part at the top of the wall does not present a lower temperature than the contiguous part, so it can be said that there is only a colour variation of the material surface which is not visible in thermogram. A very dark colour is shown at the base of the wall, due to the existence of an high concentration of moisture in the area.

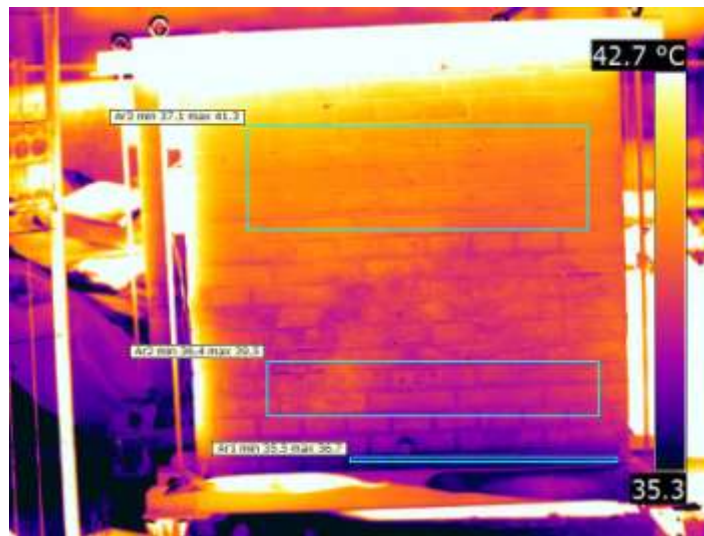
Fig 6.25 - Wall PNDE front, thermogram (IR_21932) of wall PNDE, areas and temperatures

The same thermogram for the wall PNDE (IR_21932) is presented in figure 6.25, showing maximum and minimum temperature values for different areas in the wall. The upper part, marked as (Ar3) above the efflorescence, has a maximum temperature of 41.3 °C, while the lower part (Ar2) containing moisture has a slightly lower maximum temperature, 39.5 °C. The darkest part of the thermogram (Ar1) has a maximum temperature value much lower: 36.7 °C, this correspond to the moist area of the wall.

Table 16 - Wall PNDE, temperatures from the 3 areas in fig. 6.25

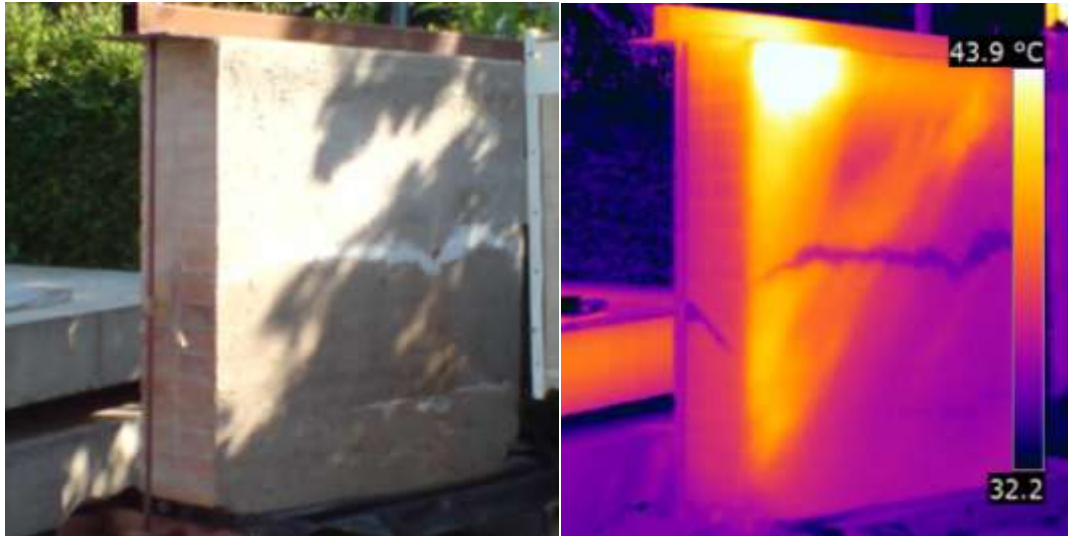
Fig 6.29 - Wall PNDA rear (left) ; thermogram (IR_22008) of wall PNDA (right)

The wall PNDA, fig 6.29, immersion on NaCl (0.1% by weight), has plaster on the rear, the presence of efflorescence is visible by a dark stripe in the thermogram with a very lower temperature. Infrared thermography technique is also able to accurately detect the phenomena of rising damp in plastered brick masonry walls.

Thermograms corresponding to the walls PNDA, PNDC and PNDD were post-processed choosing same range temperatures (32.2°C; 43.9°C) in order to make a comparison between walls.

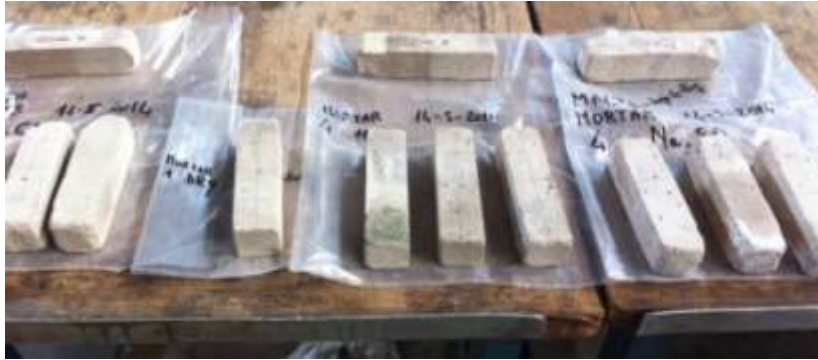
Fig 7.1 - Set of mortar samples, three used in compression test

Three mortar samples were used without any change, however, each brick was cut and numbered according to the examples in fig 7.2. After cutting and smoothing of the surfaces the small samples of bricks were dried in the oven for at least one day. Special care was taken to obtain representative specimens which are straight and uniform in cross section. It was necessary to verify their planarity, (faces planar and parallel), in order to apply an uniform load in the sample. After this procedure the samples were dried again at 70°C for 16 hours.

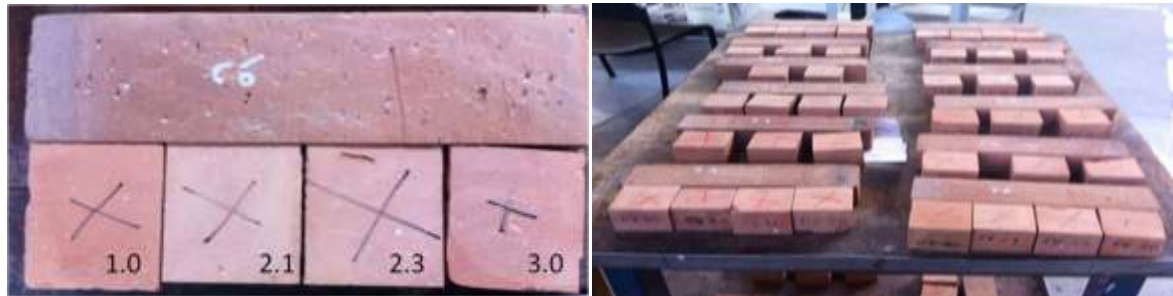
Fig 7.2 - Example of the brick C6 and its notation, cut into 4 small bricks (left) ; Sets of different bricks (right)

From the set of 72 small cubes (6 bricks of each series NaCl, Na₂SO₄ and Water were cut into four small bricks), 12 samples were taken (4 with NaCl; 4 with Na₂SO₄; and 4 with water) to perform the mechanical test with the electric extensimeter. The remaining 60 samples were used to perform compression tests without extensometers. The 12 cubes were first measured and weighted, and then instrumented with two strain gauge or with two rosettes on opposite vertical faces, according table 17.

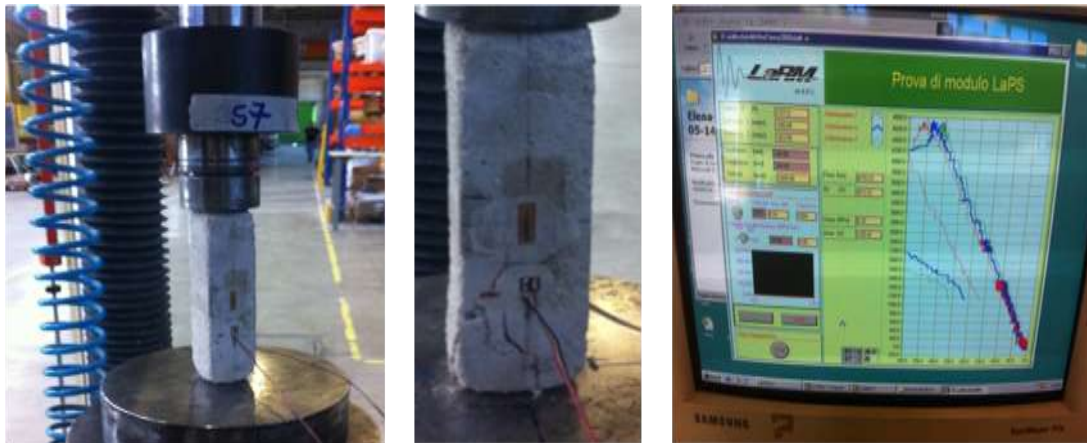
Fig 7.4 - Compression test in mortar sample S7(Left) ; Compression test in mortar sample S7 - Rupture (middle); Data acquired in the computer (right)

The axial and transversal (applying rosettes) displacements measured via the strain gauges were used to recover the stress-strain diagram and thus to determine some parameters characterizing the behaviour of the samples under compression, the static Modulus of Elasticity, Poisson ratio and compressive strength. According to the European Standard (EN1015-11, 2007), the tests to determine the compressive strength were performed in 3 different types of mortar samples (NaCl, Na_2SO_4 and Water). For each mortar sample, the test consists in applying three load cycles. The first of 100 N, the second of 150 N and the third cycle in order to achieve rupture, fig 7.4. With regard to the bricks samples, just one load was applied until the rupture, fig 7.5, each compressive test was performed with a velocity of 1MPa/s. Data is directly acquired from the computer, that gives a chart of load /displacement.

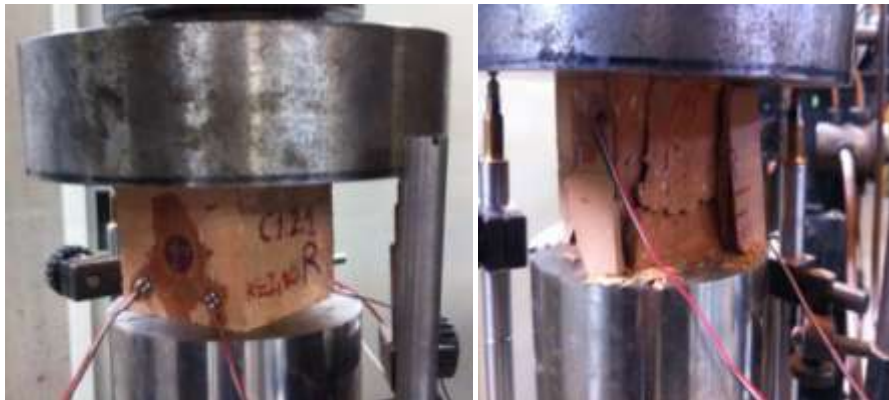
Fig 7.5 - Compression test in mortar sample C1_2.1 (left) ; Compression test in mortar sample C1_2.1 - Rupture (right)
